Pentium[®] Pro Processor Specification Update

Release Date: December 1998

Order Number: 242689-034

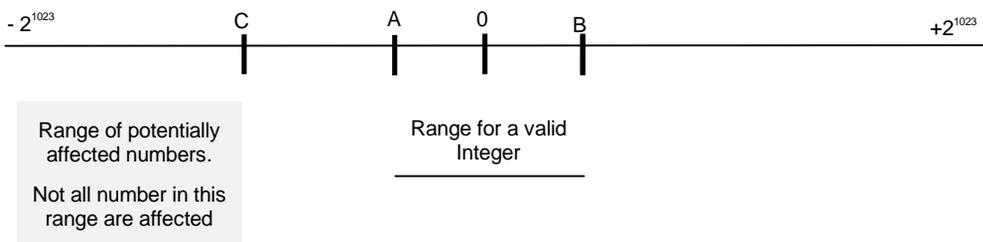
IMPLICATION: Erroneous operation results when the operand is so large that it will not fit into the target data size. The operands affected by this erratum are significantly outside (by a factor of 3X) the range that can be, correctly, converted to an integer value. The figure below and corresponding table identifies the normal range of integer numbers (between A and B) and the starting point of the operands affected by this erratum. Discrete failing operands will be present in the range between point C and the maximum negative number that can be represented by the processor (-2^{1023} in double precision format). Note 2 below gives a qualitative description of the nature of the discrete failing values. Software that does not rely on the Invalid Operation exception flag being set and signaled by either an exception OR by software polling is not impacted by this erratum.

16-bit Operation	A	B	C
	-32,768.0	+32,767.0	< -98304.0
32-bit Operation	A	B	C
	-2,147,483,648.0	+2,147,483,647.0	< -6,442,450,944.0

WORKAROUND: Any of two software workarounds will avoid occurrence of this erratum:
